# Wood-Fired Cooking Challenge

Aqua Riva Restaurant Experience  
Vancouver, Canada

# Wood-Fired Rotisserie & Pizza Oven

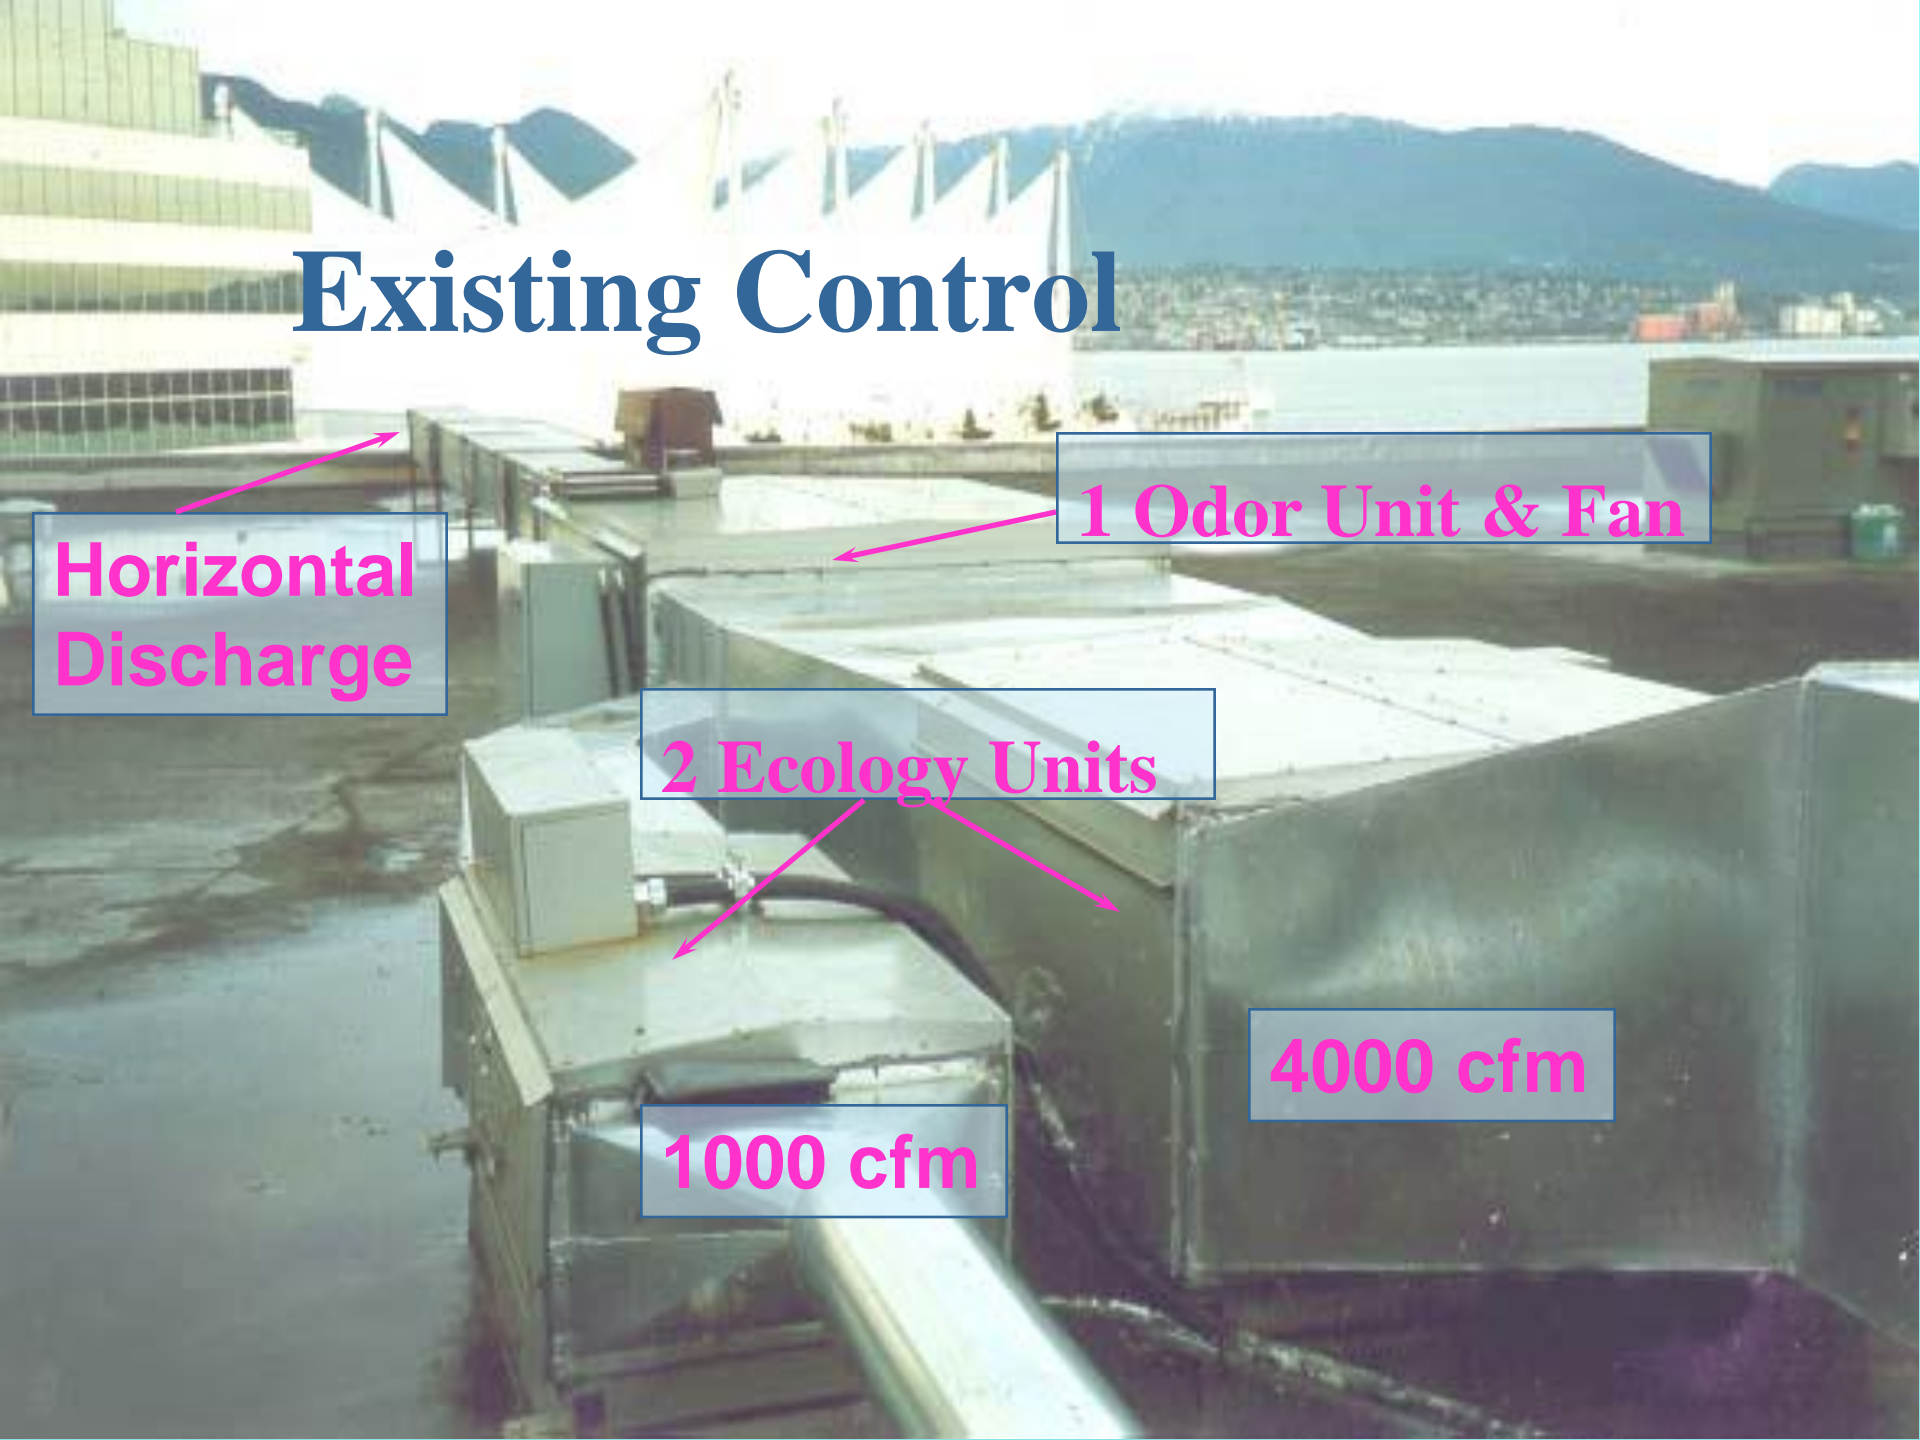
# Existing Control

Horizontal  
Discharge

1 Odor Unit & Fan

2 Ecology Units

4000 cfm

1000 cfm

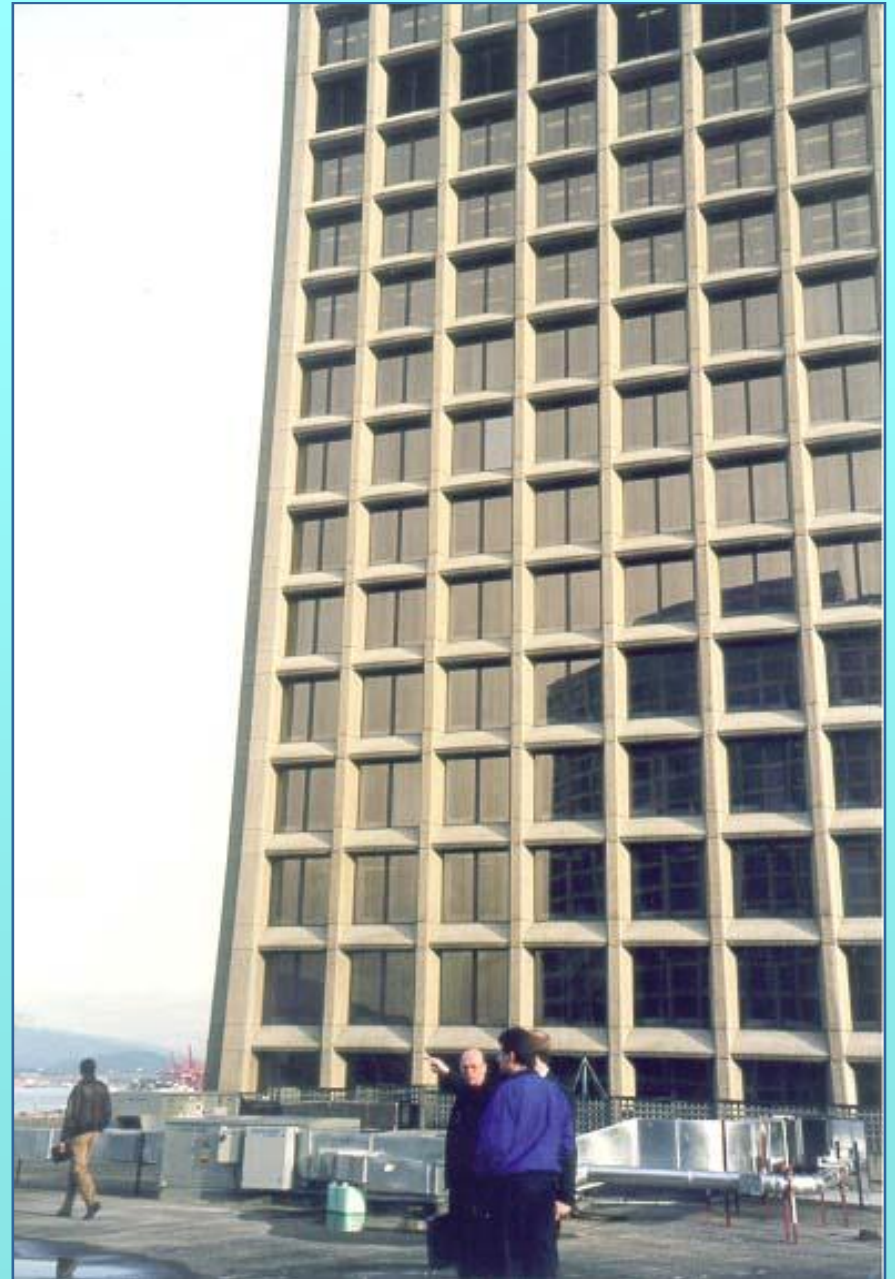
# Still a Problem

Complaints from  
adjacent office  
tenants about wood  
smoke odors

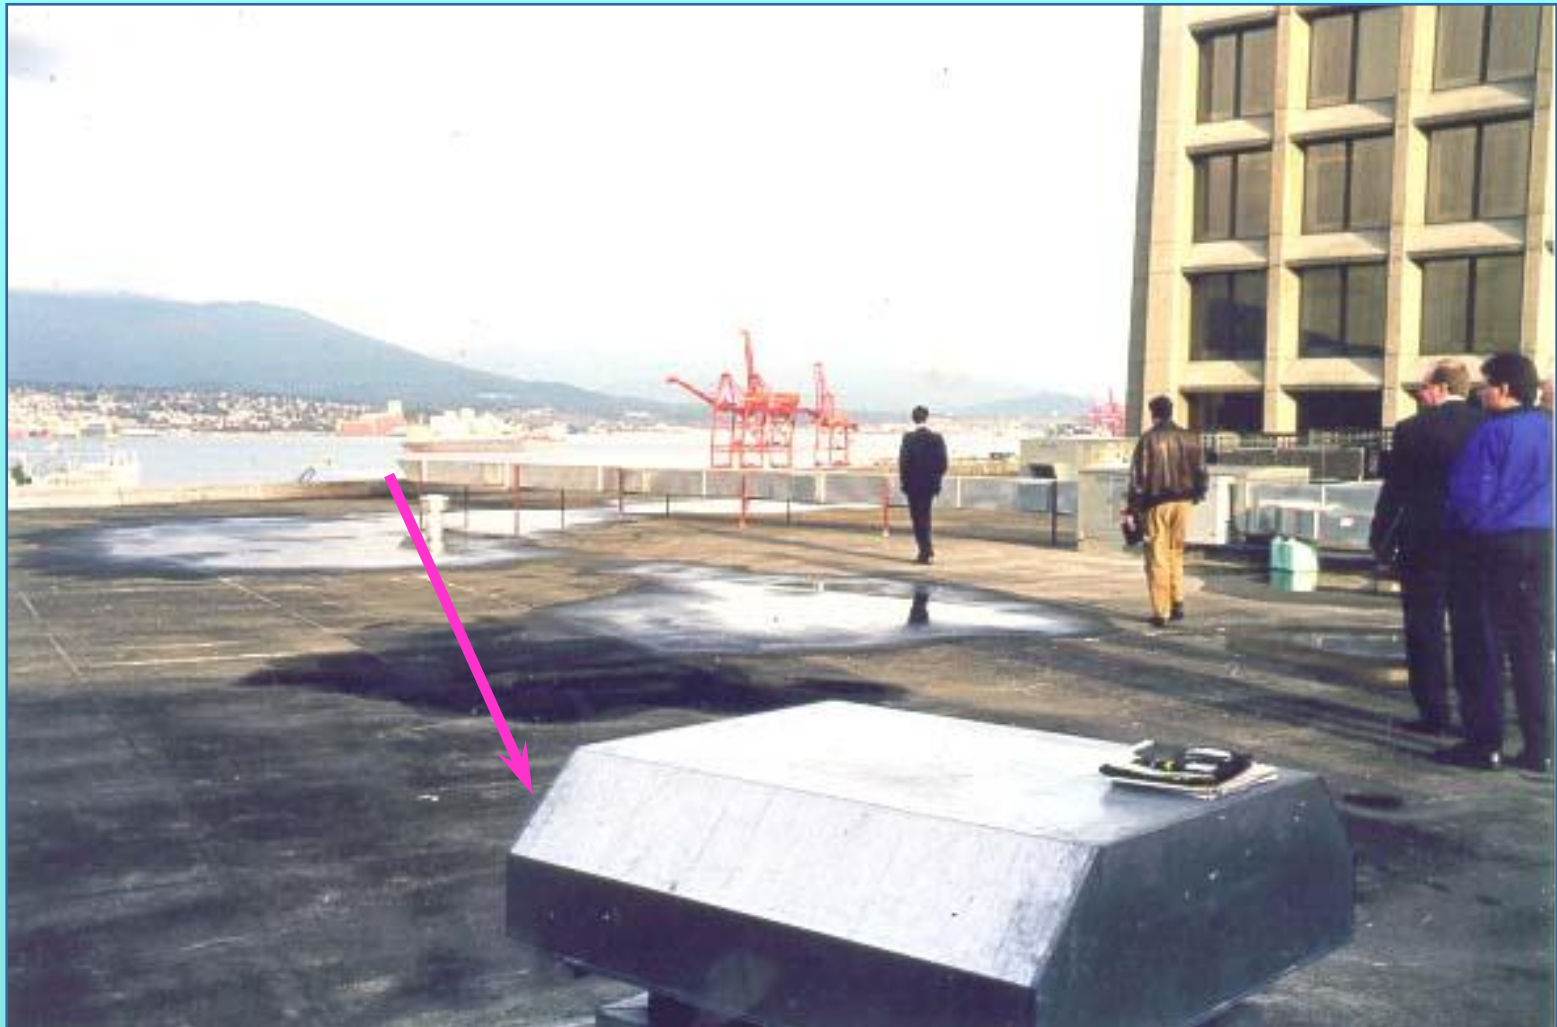
# Even Bigger Problem

Odor complaints from downstairs tenant

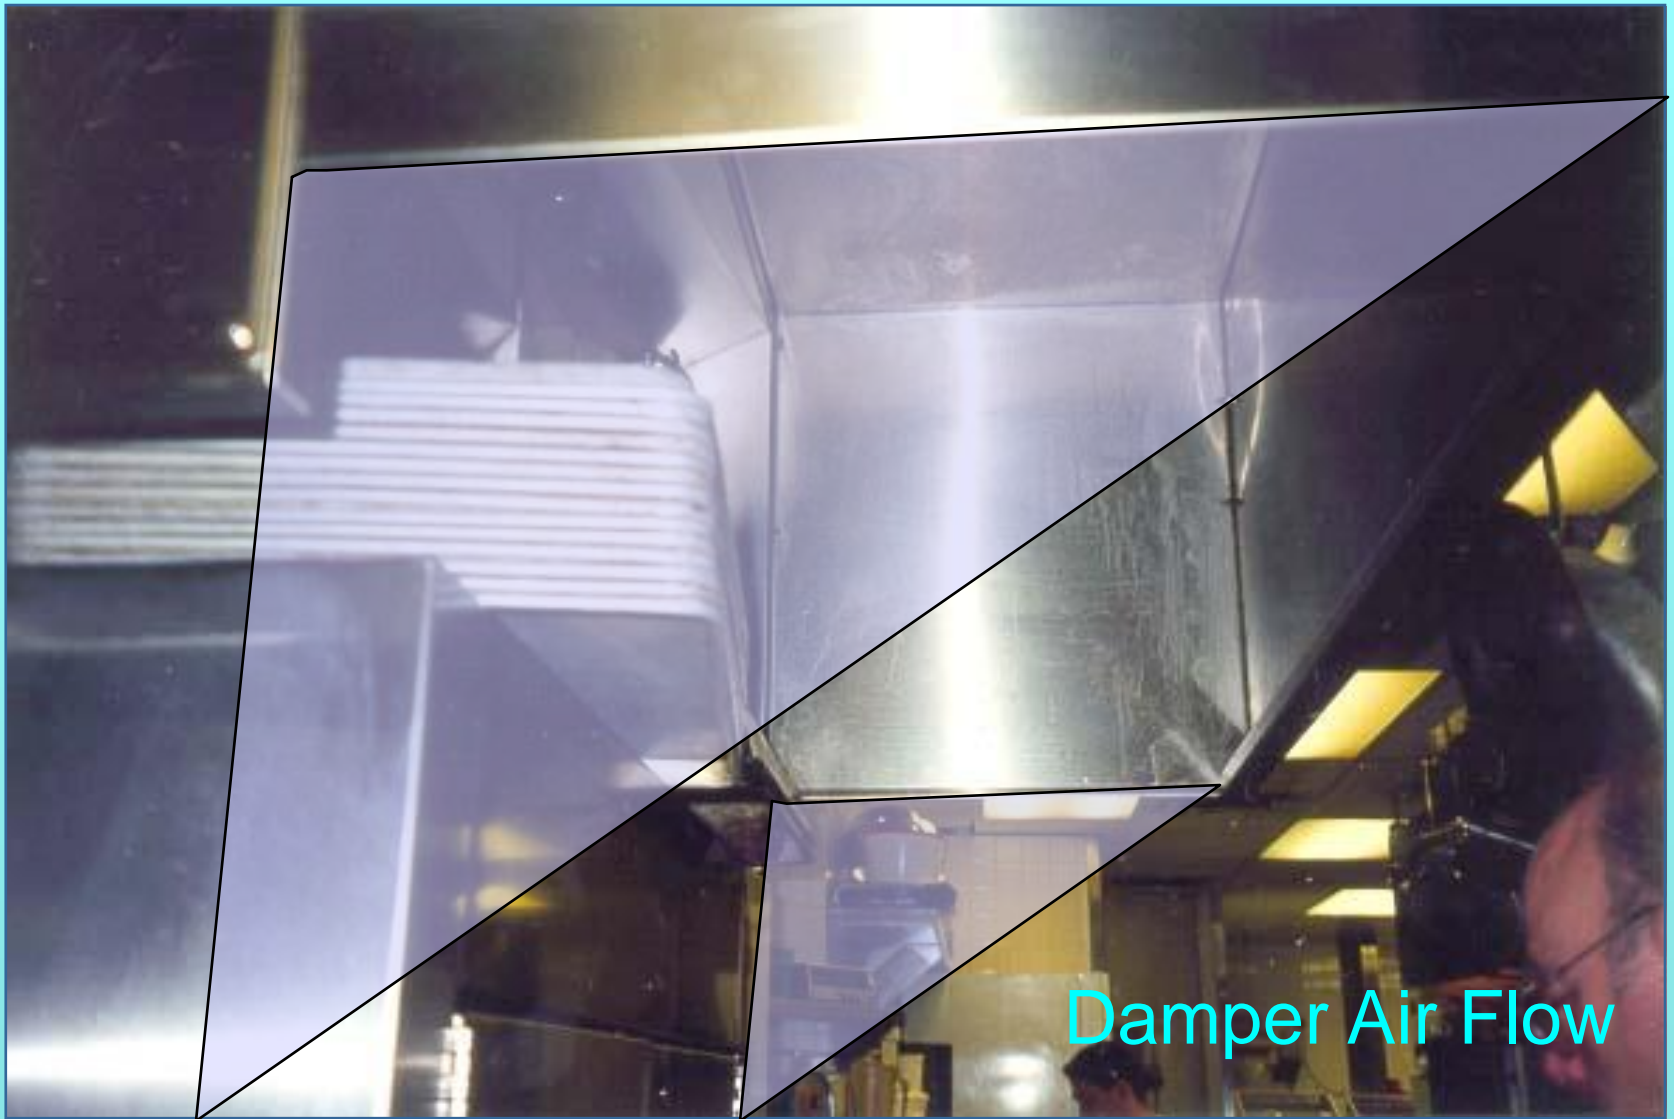
# Side Curtain Retrofit

Damper Air Flow

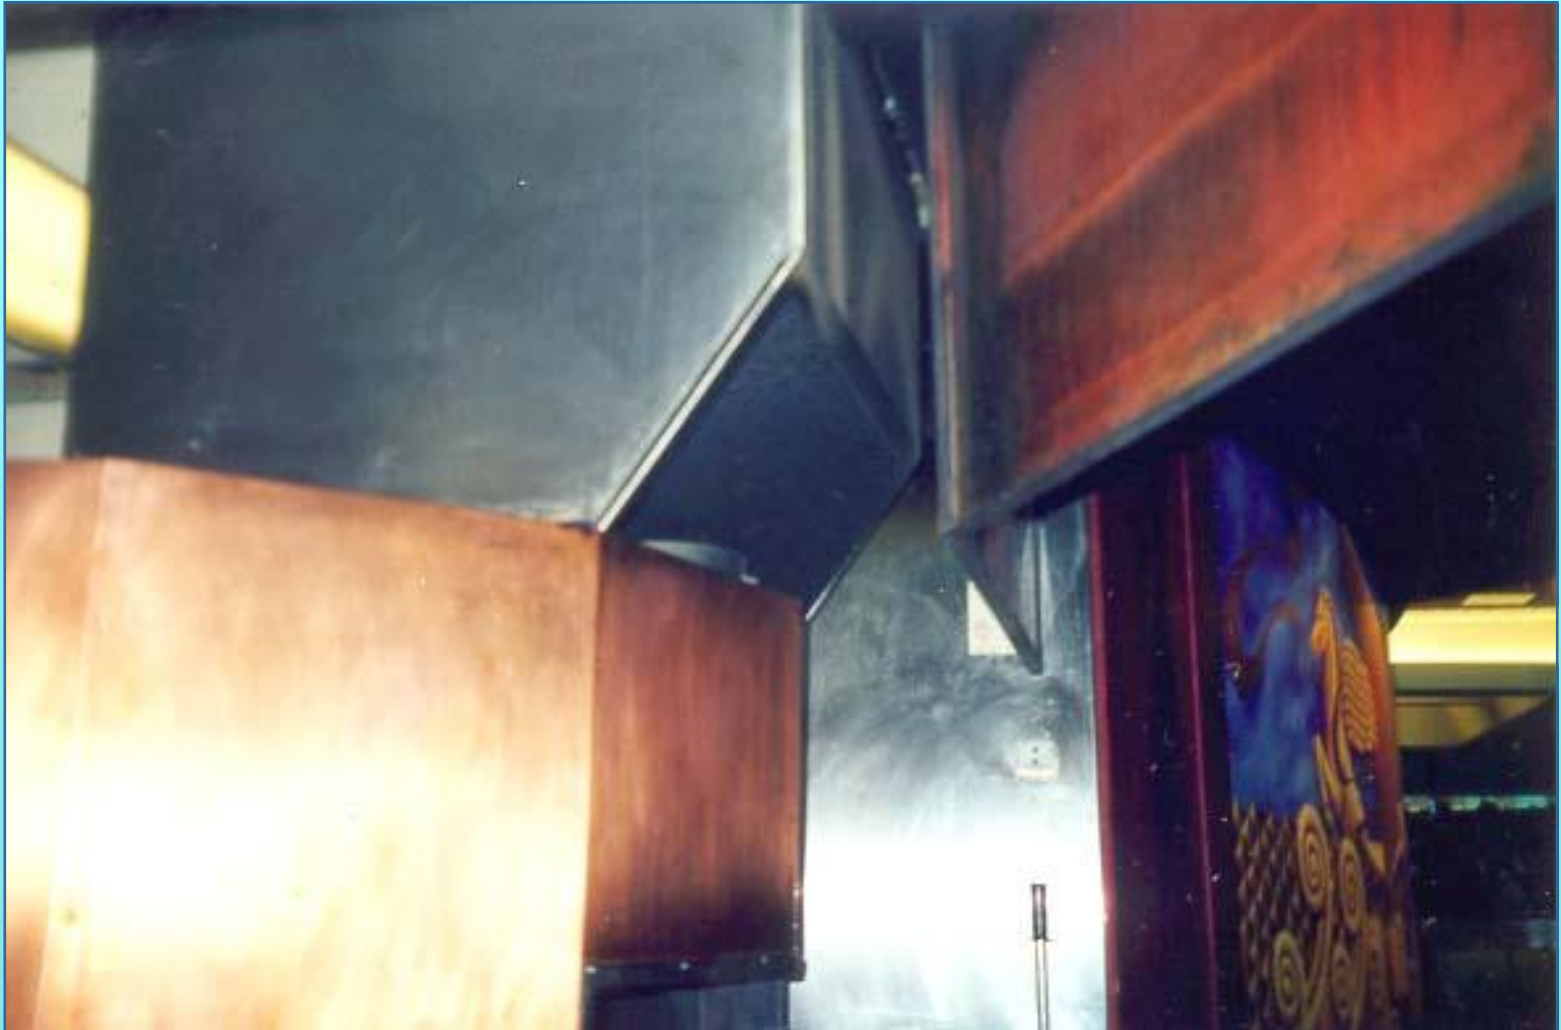
# Pizza Oven Hood

Draft style hood - open front & back

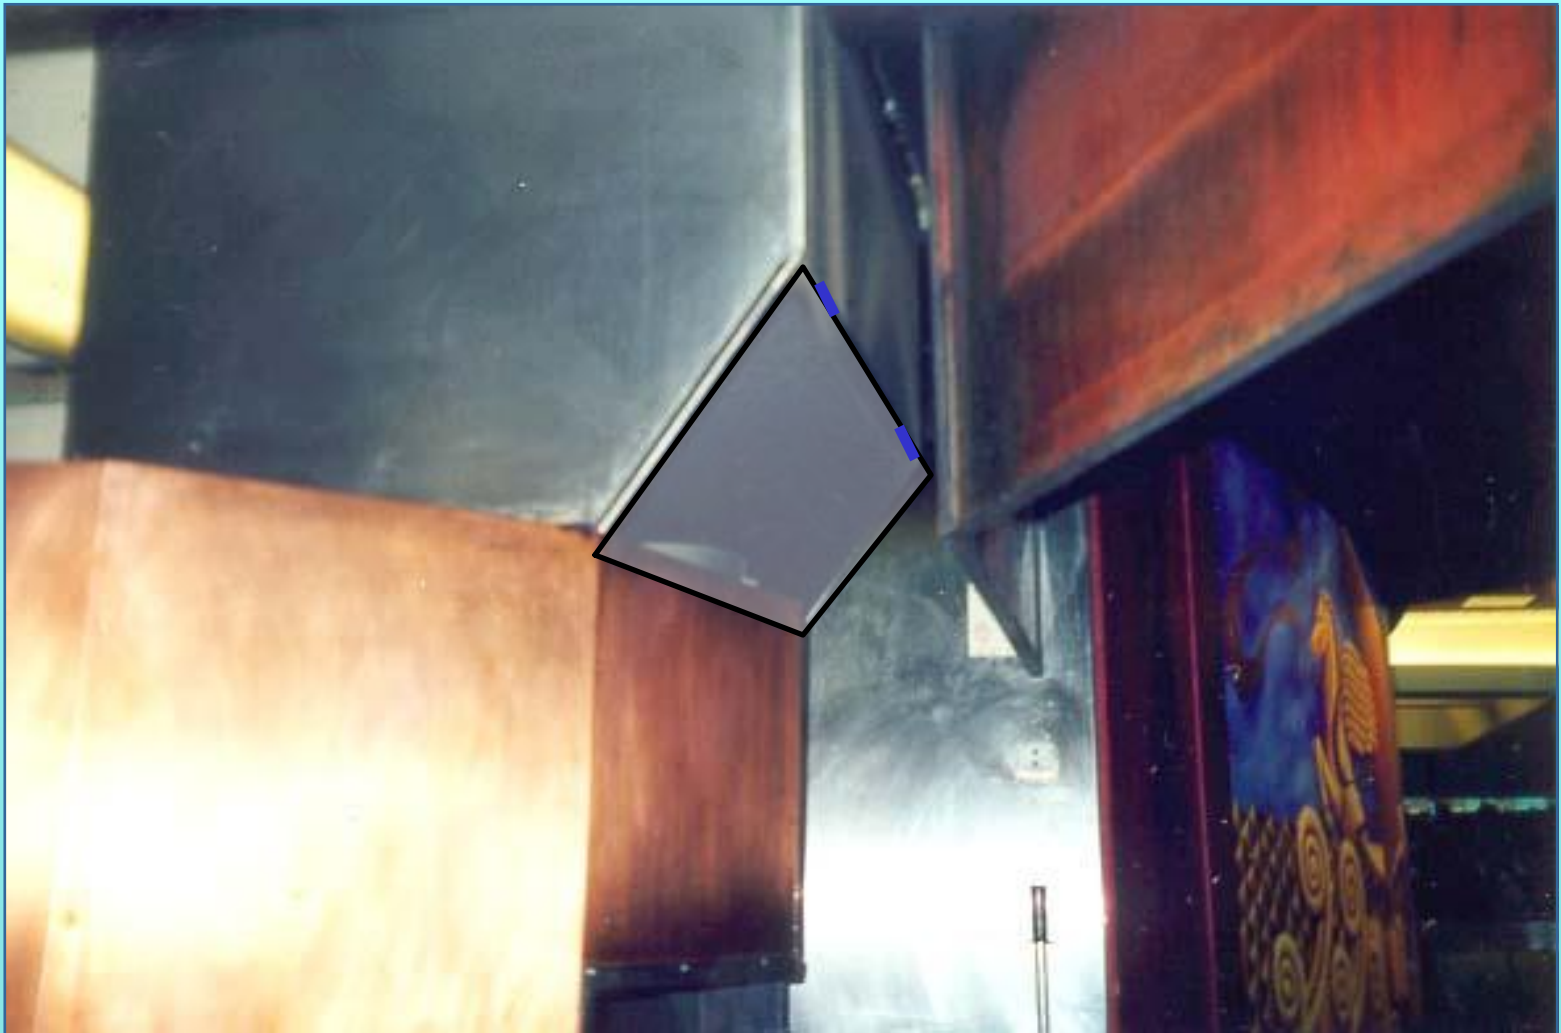
# Improved Capture

Hinged panel (access for cleaning)

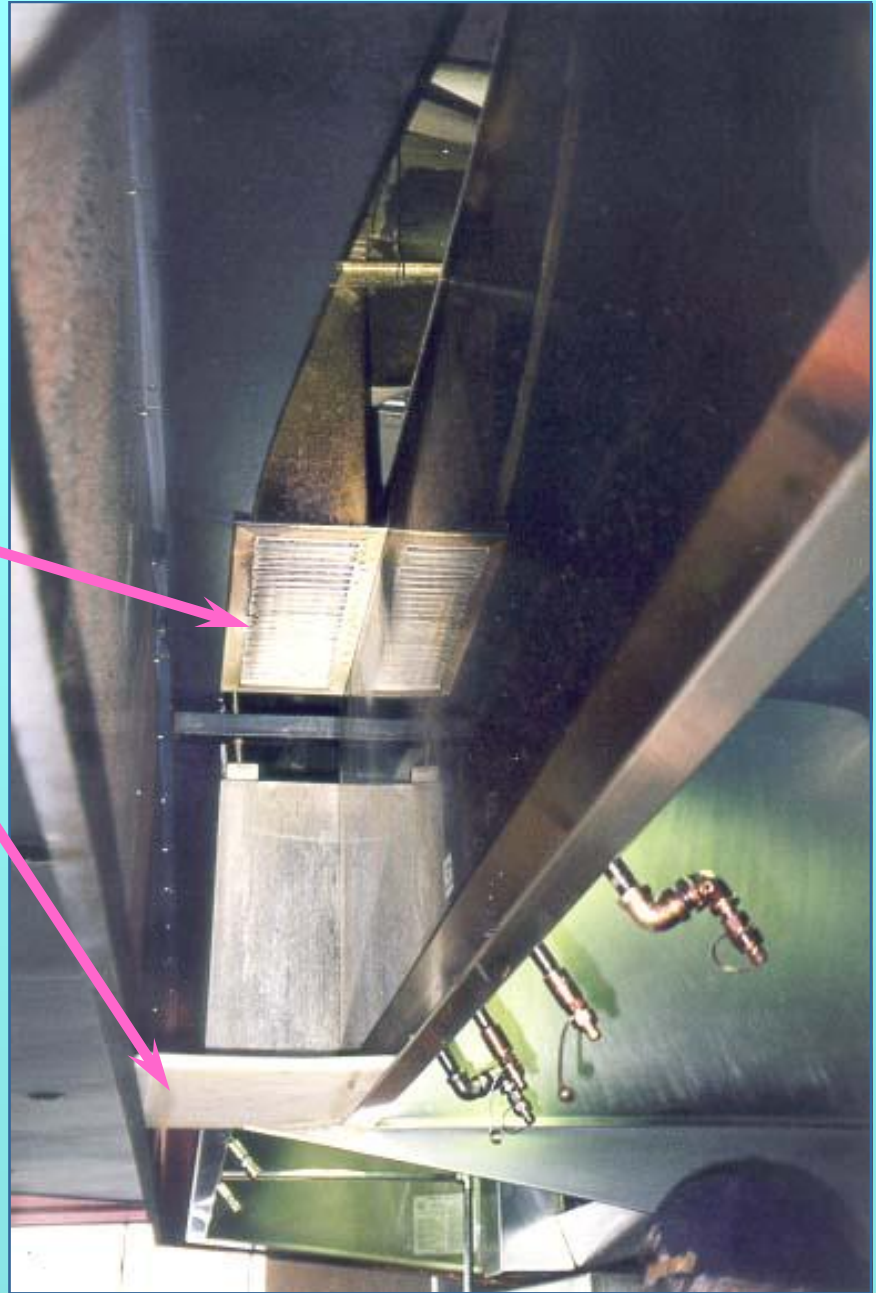
**Nasty Makeup  
Air Grille  
Location and  
Chef “Fix”**

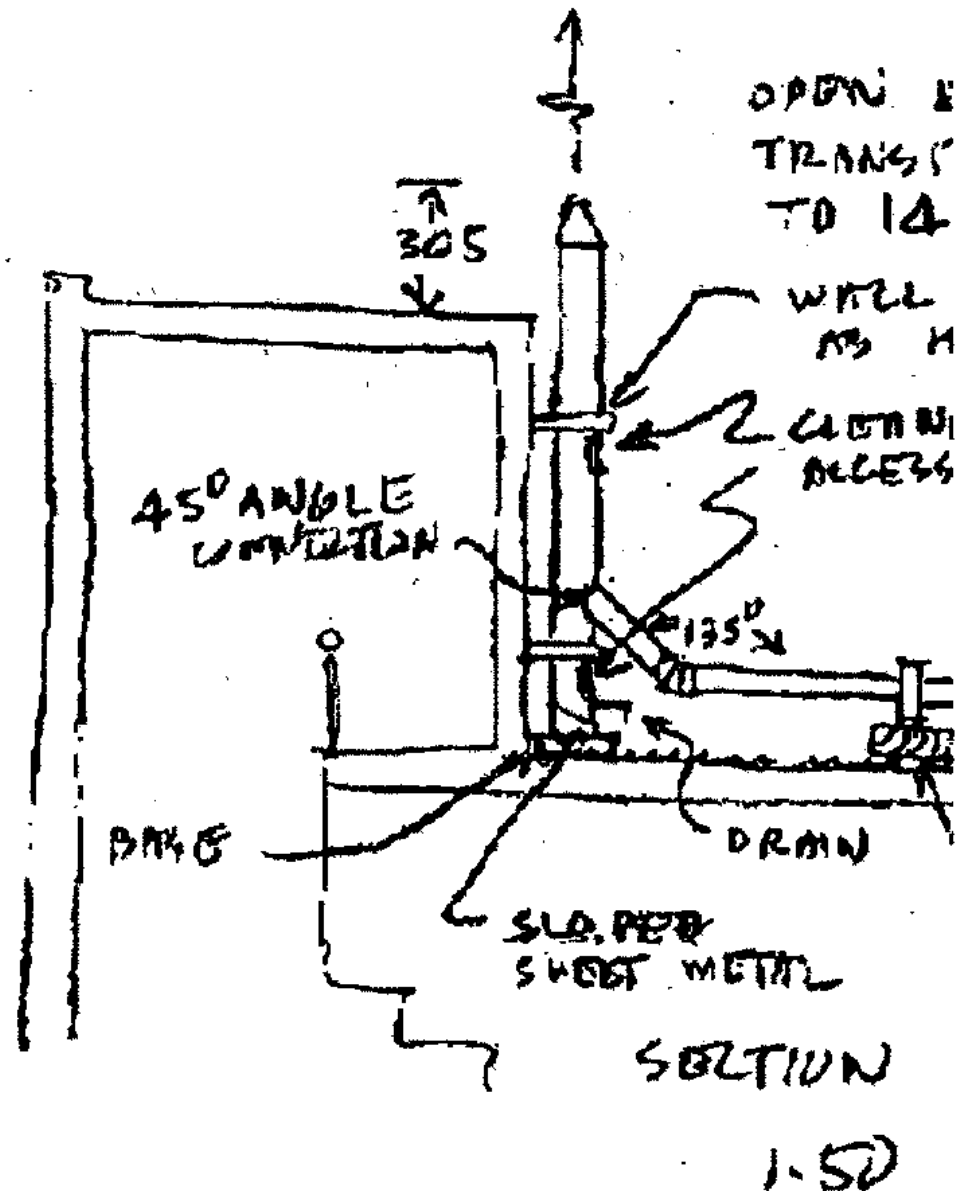
# Re-Design

High-Velocity  
Vertical  
Discharge
